Safety Bulletin No. 07a/2019

SPIKING OF HV CABLES – Update

Issue date	6 th June 2019
Issued by	Steve Luckett, System Operations Manager
Applicable to	All Operational personnel

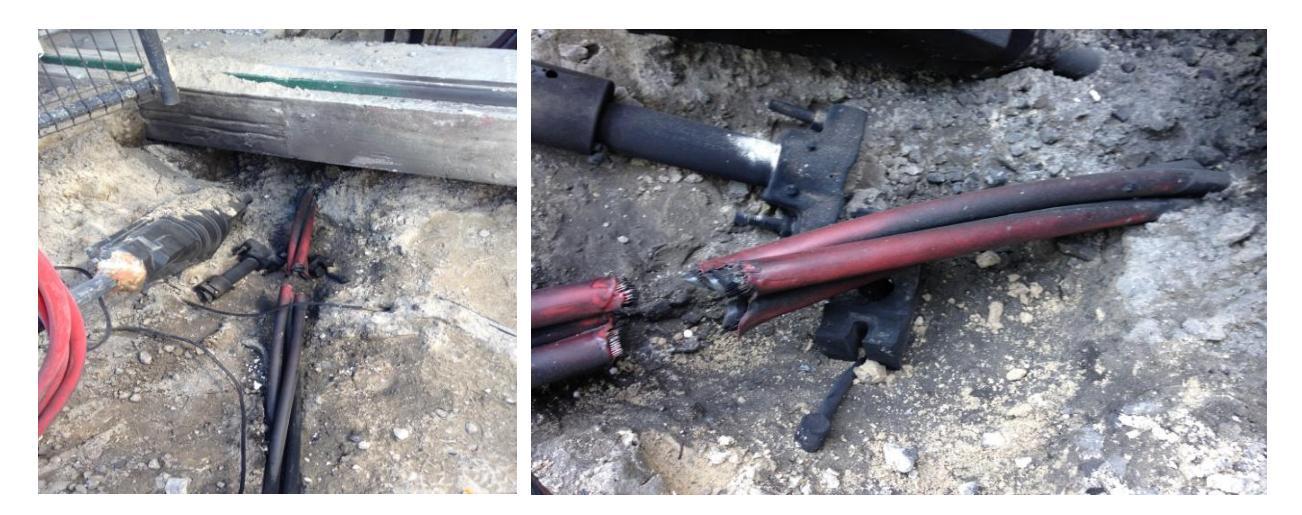
During work to loop in a new HV substation, a live 6.6kV cable was spiked in error causing an explosion and the subsequent injury to a jointer requiring treatment in hospital.

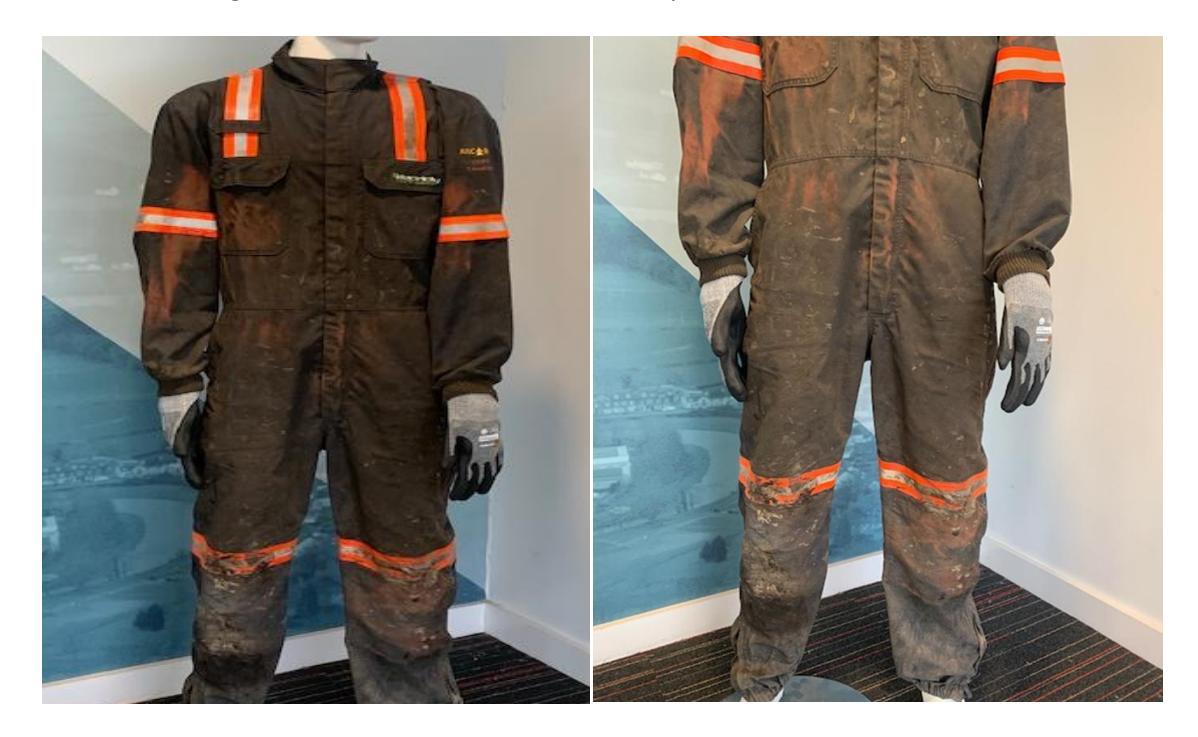
We have decided to share these pictures of the injured jointer's coveralls. The dusky orange patches around the legs, stomach, torso and arms are the scorch marks left from the flash. Had this incident occurred prior to introduction of the arc-resistance coverall, the injuries would have been life changing or worse. This is a stark reminder that when primary risk controls fail, PPE is the last form of defence and why it is mandatory to wear it. During use, the arc resistant coverall shall be worn correctly, with both sleeves covering the arms down to the wrist and fully fastened at the front to the neck.
