Safety Bulletin No 08/2019

## Safety Devices

During the inspection of a mobile elevating work platform (MEWP) fitted to a Bigtrak, a serious defect and safety hazard was found.

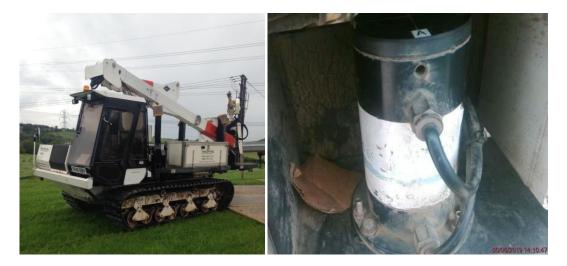
An inspector discovered that the tilt sensor, a critical safety device fitted to prevent overturning during extension of the boom, appeared to have been tampered with in an apparent attempt to override the safety function.

A safety investigation is to take place. However, initial indications are that this critical and potentially lifesaving safety device has been deliberately defeated. Through use of a small piece of cardboard wedged under the sensor, the machine could be used on a surface with a slope greater than its design capabilities and which may cause the machine to overturn.

A full inspection of all machines owned and operated by ENW will be performed to confirm that the tilt sensor is operating fully. **Please note: these devices are fitted for a specific purpose — to keep us safe.**

- 1. Staff are reminded that safety devices are installed to keep you and your colleagues safe
- 2. To interfere with or alter such devices is extremely dangerous and reckless
- 3. Under no circumstances should safety devices be altered or interfered with
- 4. Guidance on use of MEWPs can be found in CP430, Pt.1 Mod 255 WORK AT HEIGHT
